Manhole Inspection Summary

Manhole # S17M__036MH

Location Address: **2401 ashton-frederick shopping center** Cross Street: **s catherine**

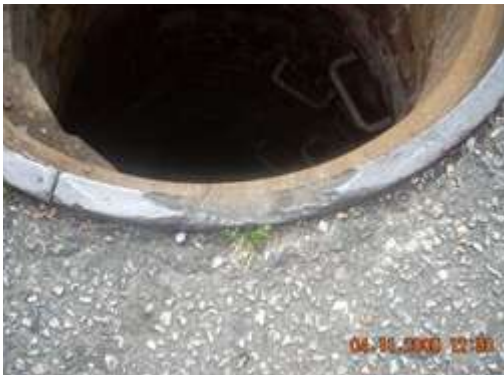
Defect 3

worn frame

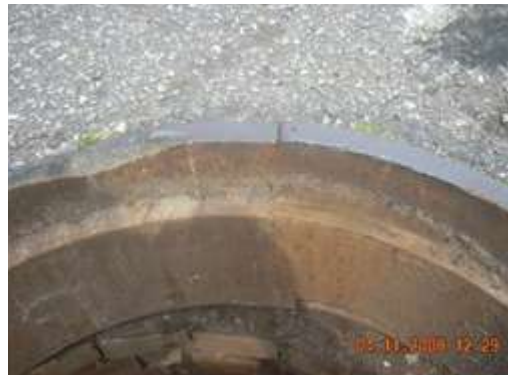
Defect 2

Frame Offset: **2** (in.) Condition: ☐ Sound ☒ **Cracked** ☐ Leaks

cracked frame

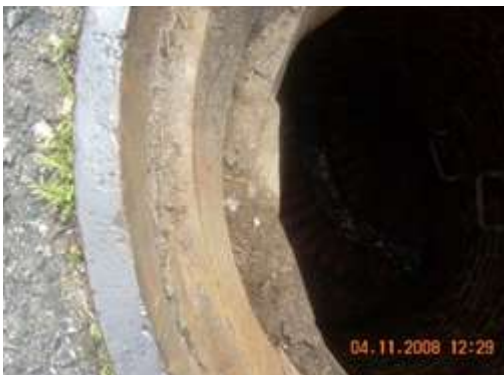
Defect 1

frame offset

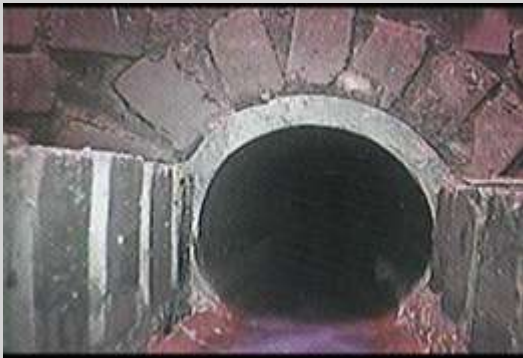
12 O'Clock Outflow

8 in. Circular Gravity Sewer
Pipe Out @ 12 O'Clock

Pipe Height: **7.2** (in.) Rod and Bar (Angled)
Pipe Material: **Clay** ☐ Pipe Lined
Invert Depth: **9.81** (ft.) Flow Characteristics: **Slow**
Deposits: ☒ None ☐ Mud ☐ ~~Gravy~~ ☐ Debris ☐ Grease
Silt Depth: **0** (in.) Deposits Extent:
Infiltration: **None** Pipe Seal Cond: **Sound**

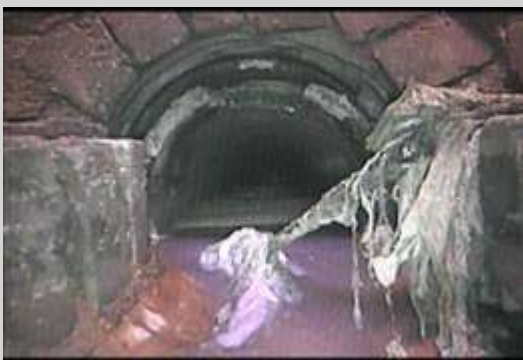
4 O'Clock Inflow

8 in. Circular Gravity Sewer
Pipe In @ 4 O'Clock

Pipe Height: **8.4** (in.) Rod and Bar (Angled)
Pipe Material: **Clay** ☐ Pipe Lined
Invert Depth: **9.75** (ft.) Flow Characteristics: **Slow**
Deposits: ☐ None ☐ Mud ☒ ~~Gravy~~ ☒ Debris ☐ Grease
Silt Depth: **2** (in.) Deposits Extent: **Medium**
Infiltration: **None** Pipe Seal Cond: **Broken**
